Exploratory Evaluation of Alumina-Ceramic Housings for Deep Submergence Service

Third Generation Housings
Volume 2: Appendices

Technical Report 1314

**NAVAL COMMAND, CONTROL AND
OCEAN SURVEILLANCE CENTER
RDT&E DIVISION
San Diego, California 92152-5001**

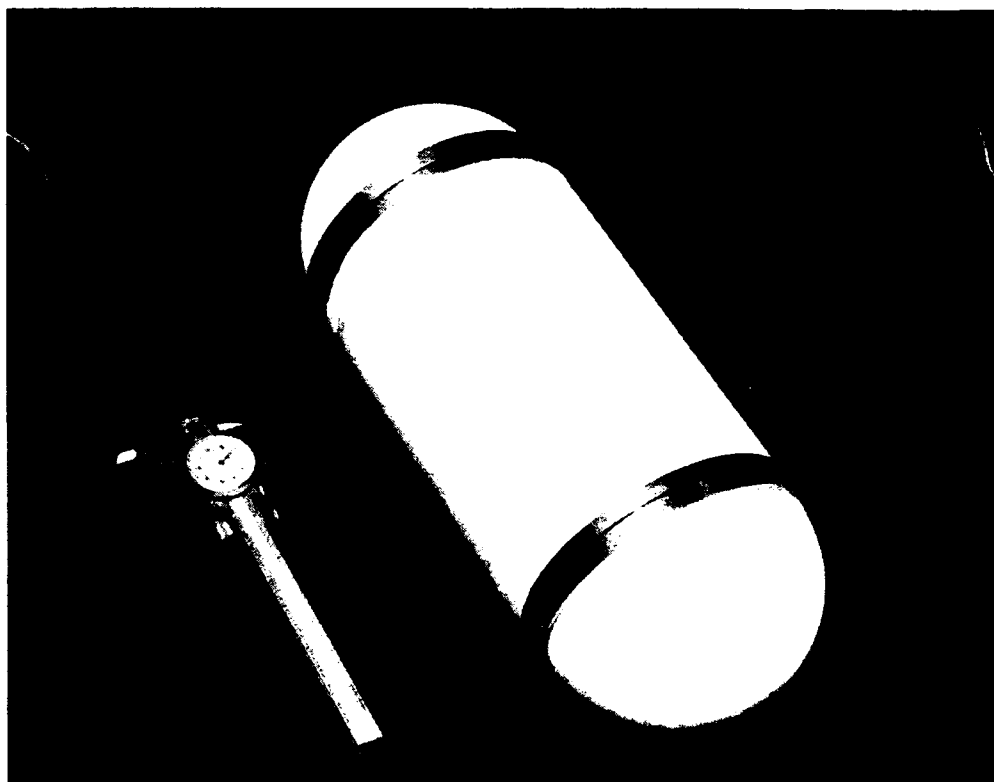
Figure A-12. The 6-inch-OD ceramic housing assembly using ceramic end closures.

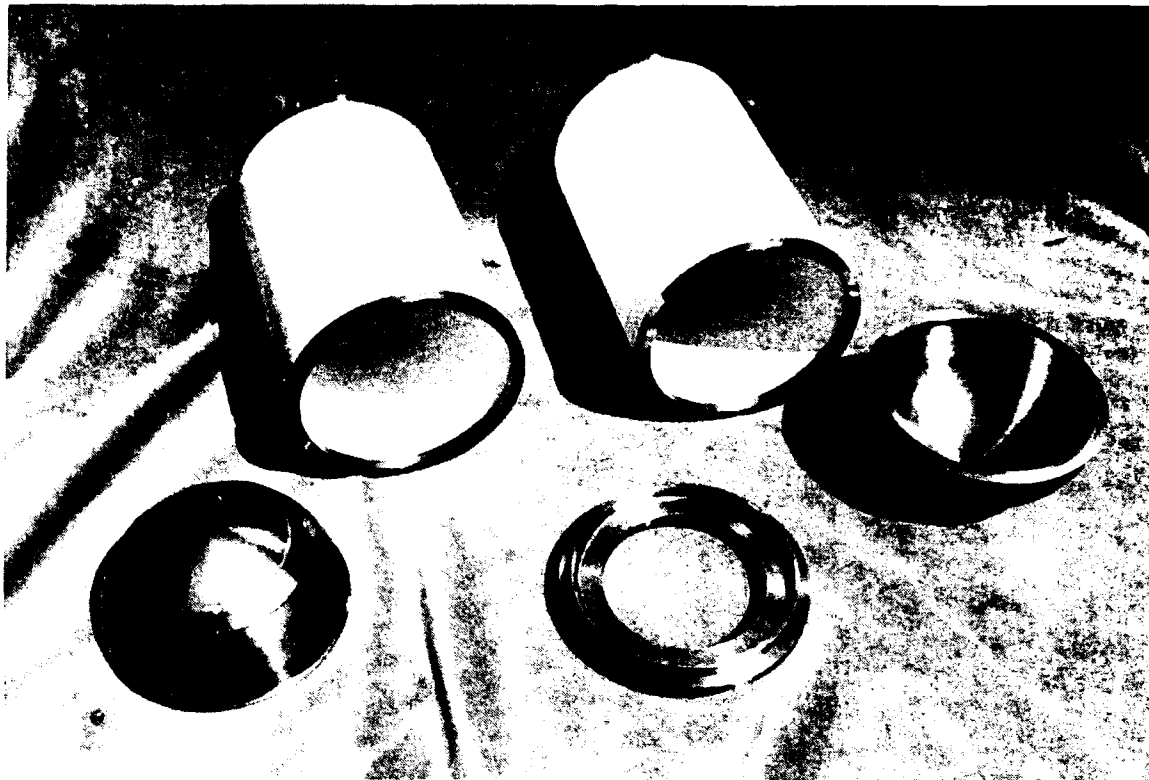
Figure A-17. Components of 6-inch-OD ceramic housing Type Y; joint ring stiffener B.

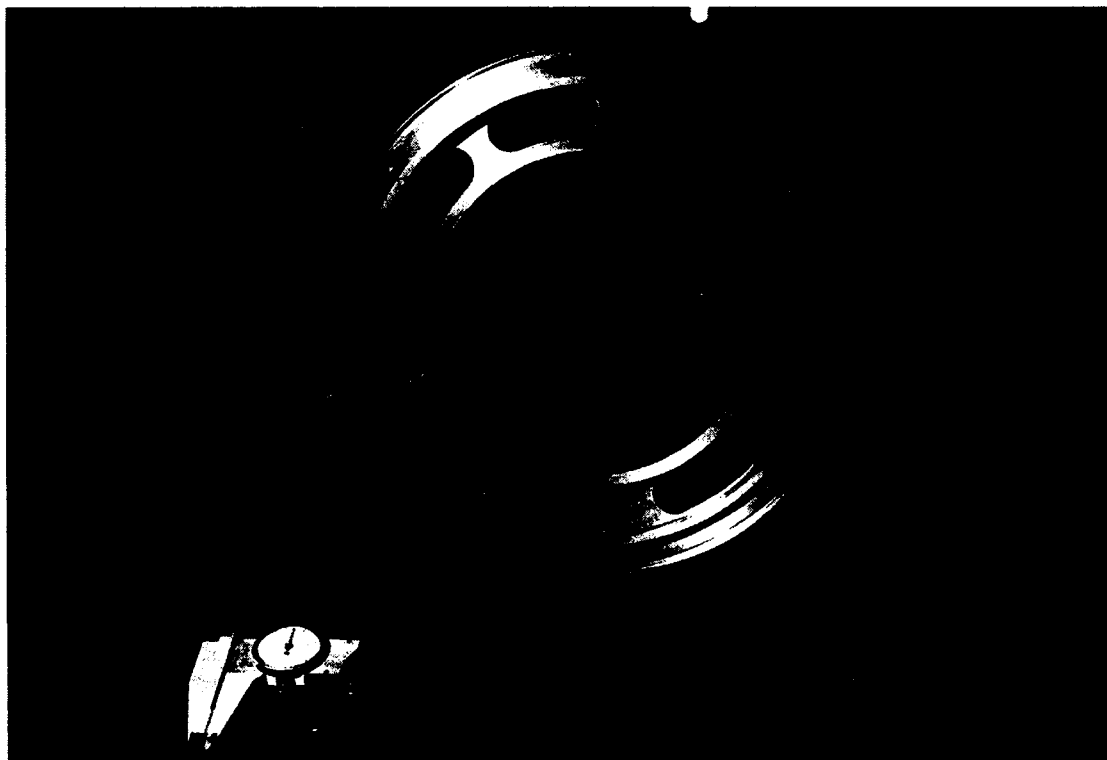
Figure A-22. Joint ring F; exterior view.

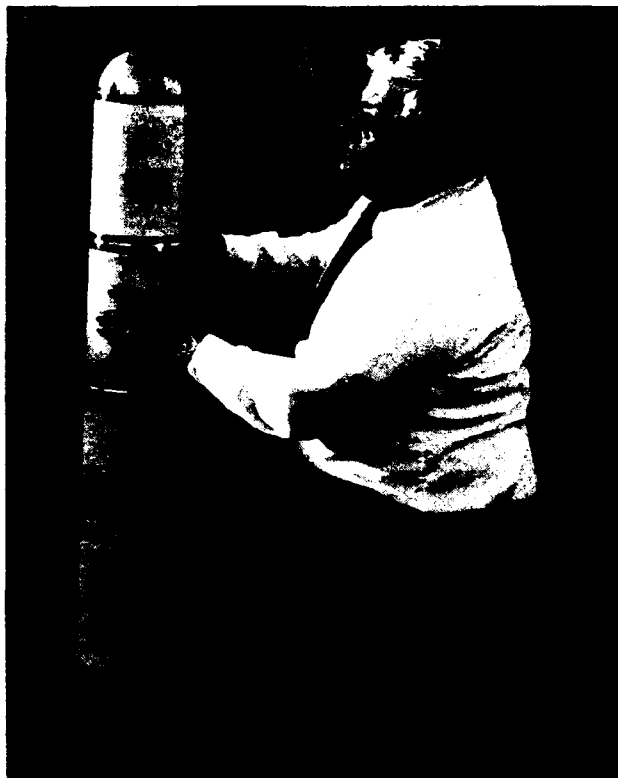
Figure A-27. Type W ceramic housing components assembled.

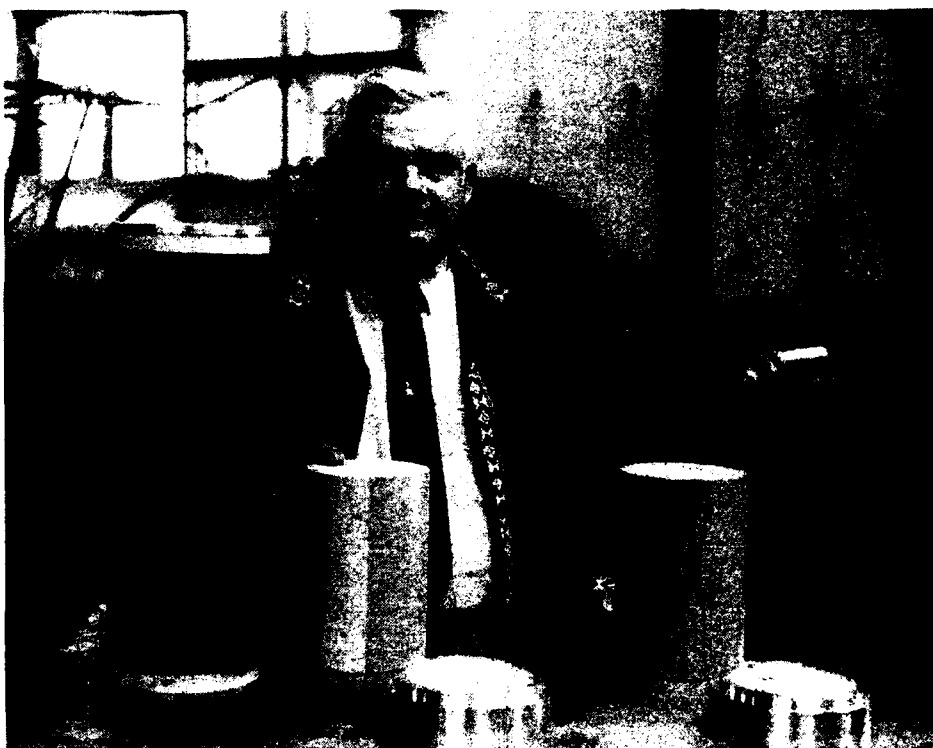
Figure A-56. Ceramic cylinder Model 3 prior to assembly with wooden plugs and metal bulkheads for implosion testing.

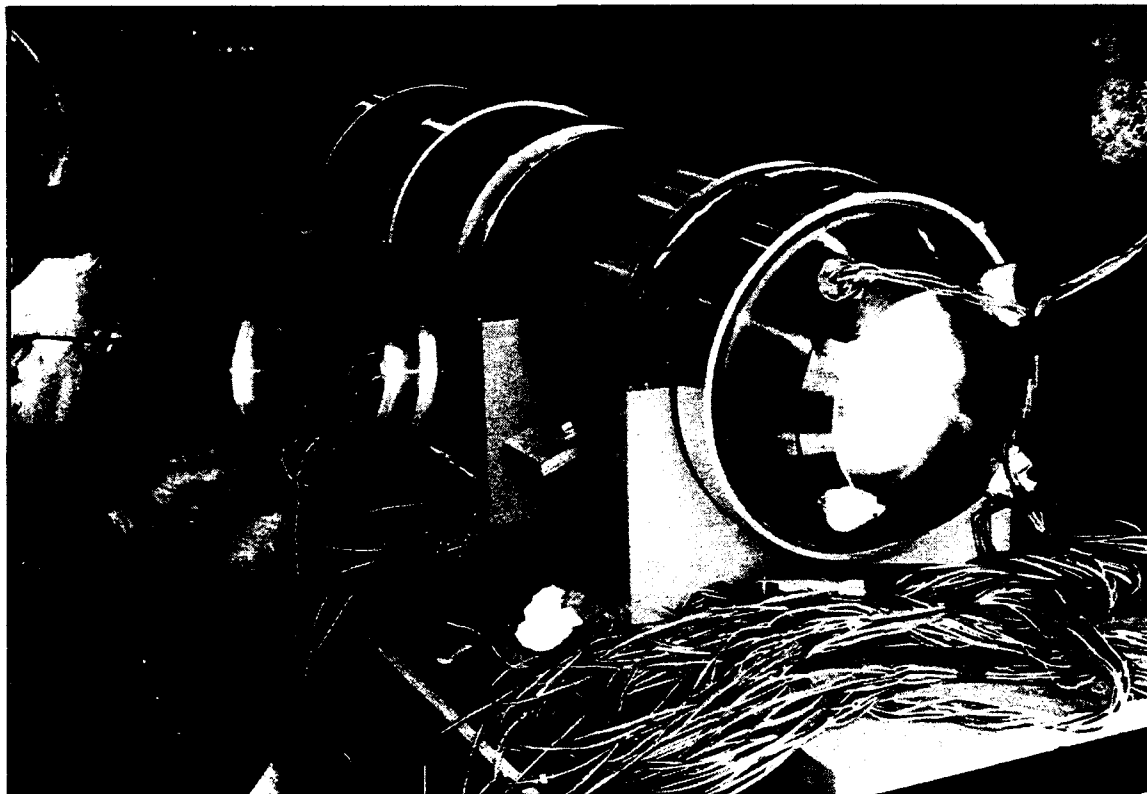
Figure B-15. Ceramic housing test assembly 1A during instrumentation with strain gages.

All stiffeners were instrumented with electrical resistance strain gages at the same locations to facilitate comparison of strain data generated by gages on different stiffeners. The locations of interest were (1) the inner surface of the inner flange, (2) the inner surface of the outer flange, and (3) the web between flanges. A nonlinear strain increase at any of these locations would signal incipient buckling or material yielding, and the test would be terminated unless someone wished to observe the failure of the stiffener.

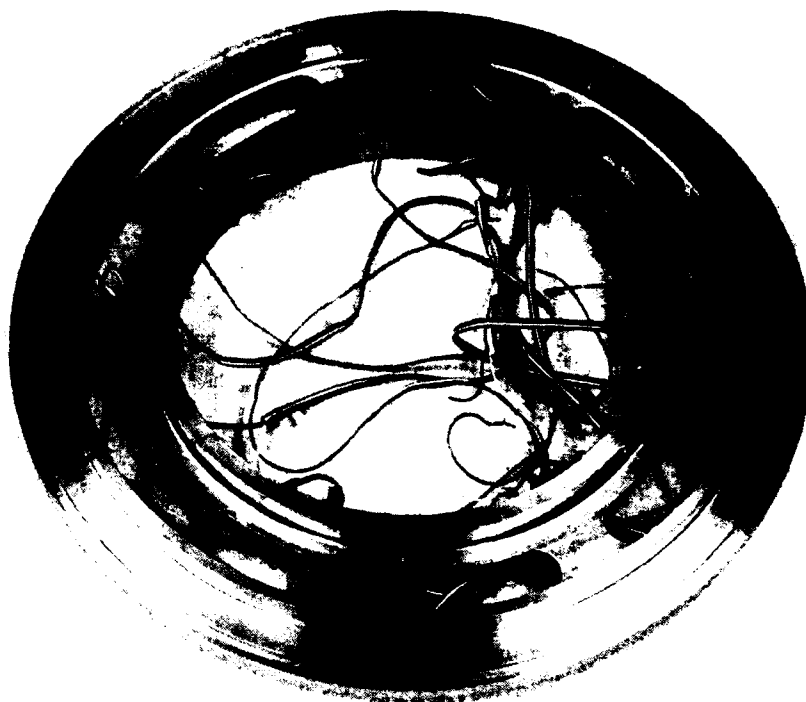
Figure B-34. Titanium ring stiffener DWG 0123943; exterior view.

Titanium and aluminum joint ring stiffeners without lightening holes did not fail at 10,000-psi proof test pressure. All strains were linear to 10,000 psi.

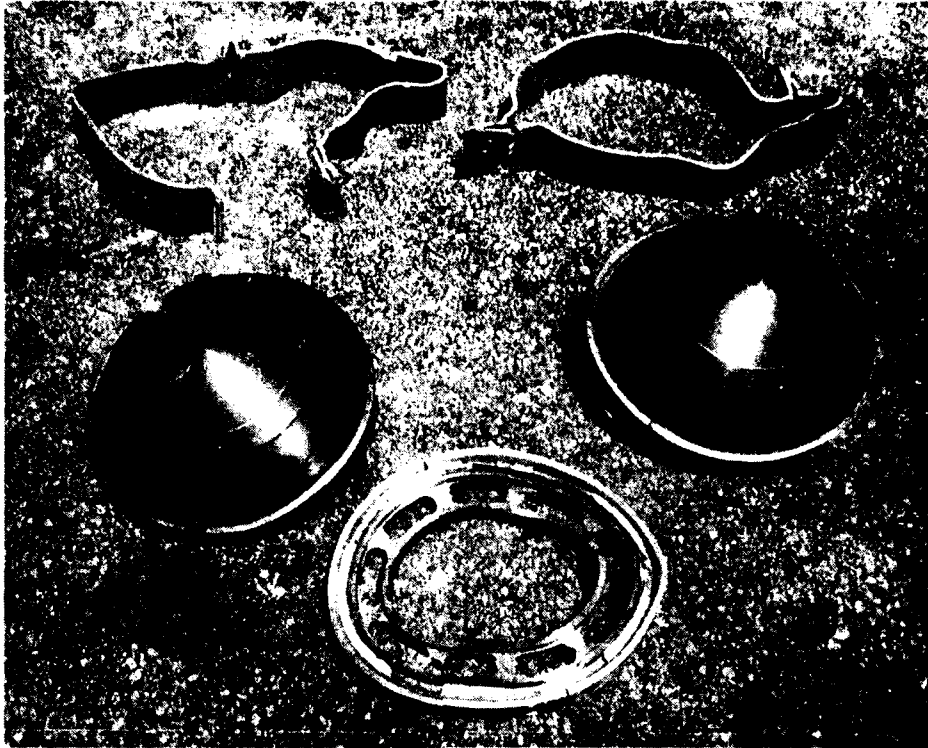
Figure B-43. Titanium ring stiffener DWG 0121604; location of gages.

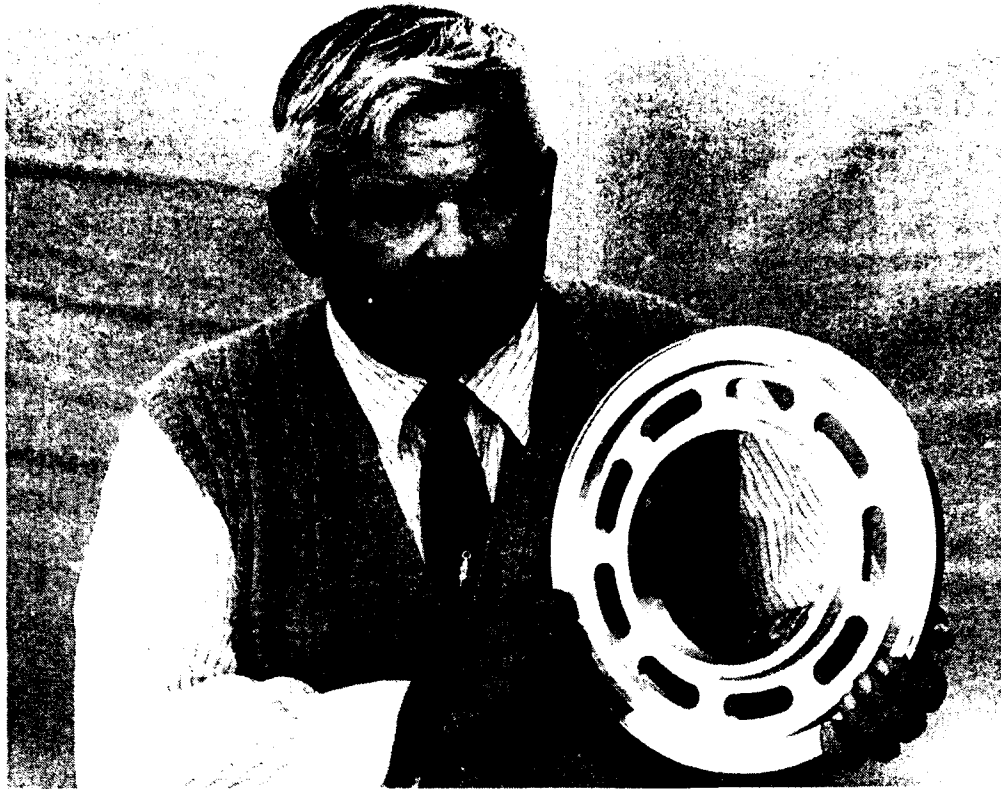
Figure B-58. Aluminum ring stiffener DWG 0124008; exterior view.

The test on the aluminum joint ring stiffener with 1-inch-wide slots (figure B-1E DWG 0124008) was terminated at 7,000 psi without failure or departure of strains from linearity. Table B-1 lists the different test assemblages, and table B-2 is a summary of proof and cyclic pressure tests run on all test assemblies. Tables B-4 through B-20 show complete strain and stress breakdowns.

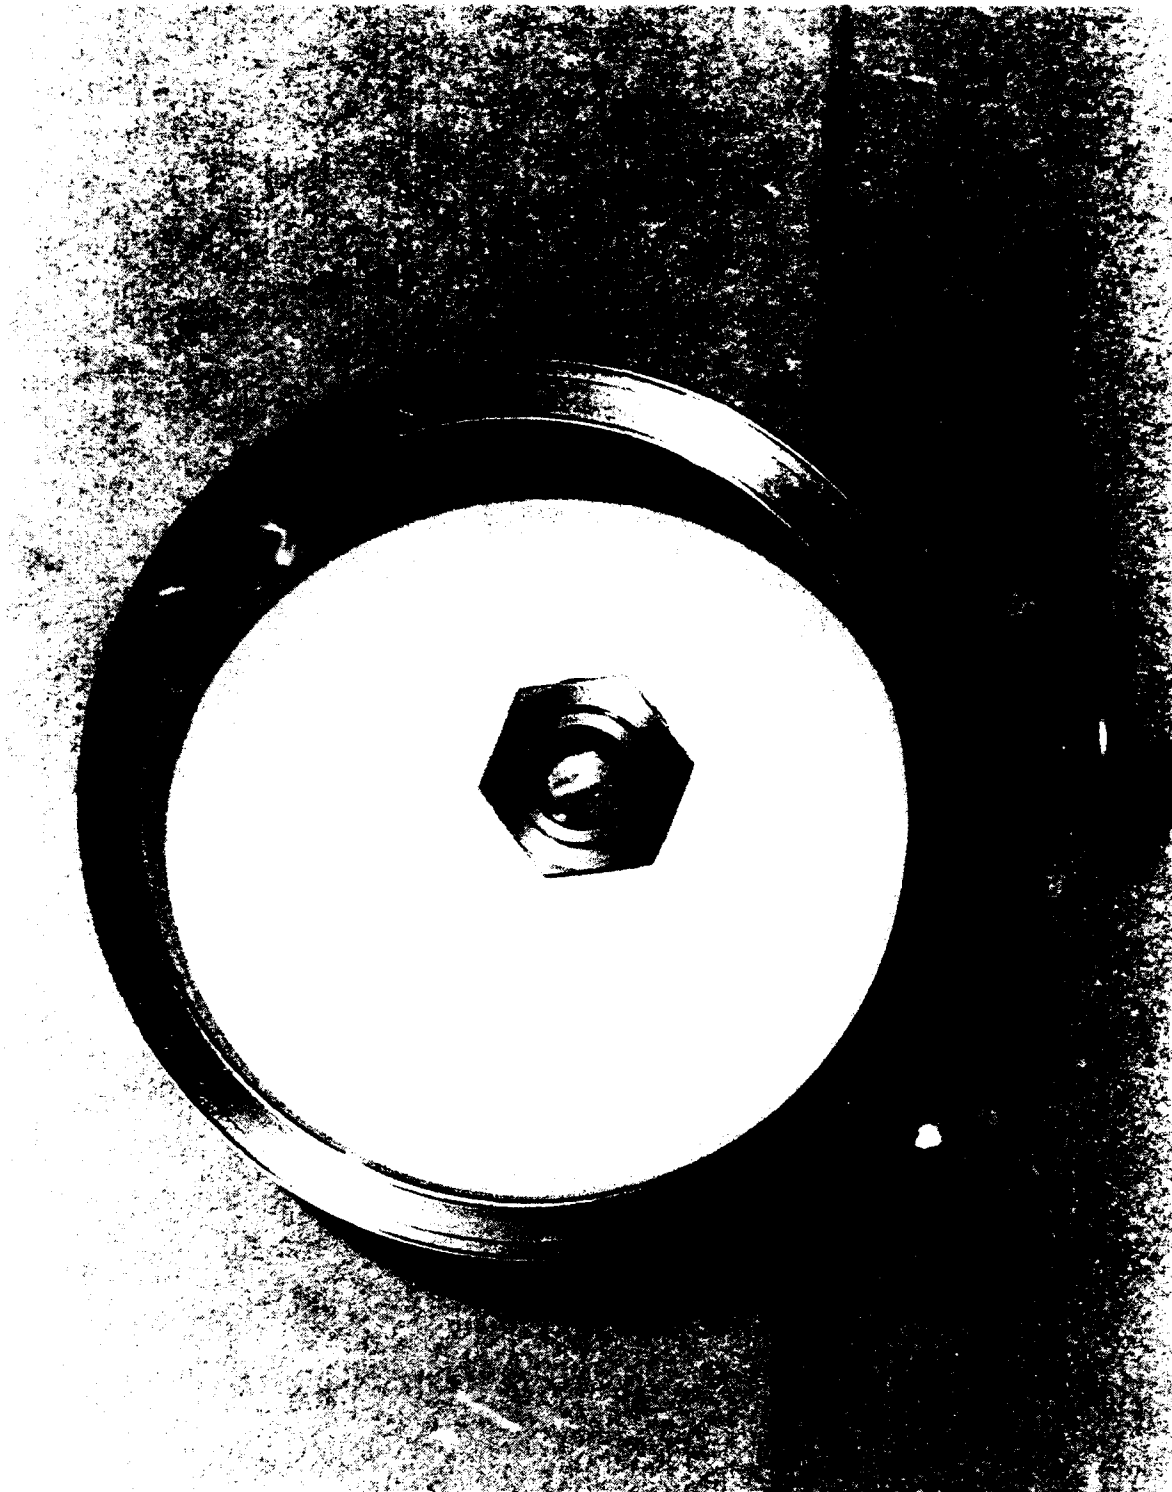
Figure C-11. Ceramic bulkhead assembly Mod 1; interior view.

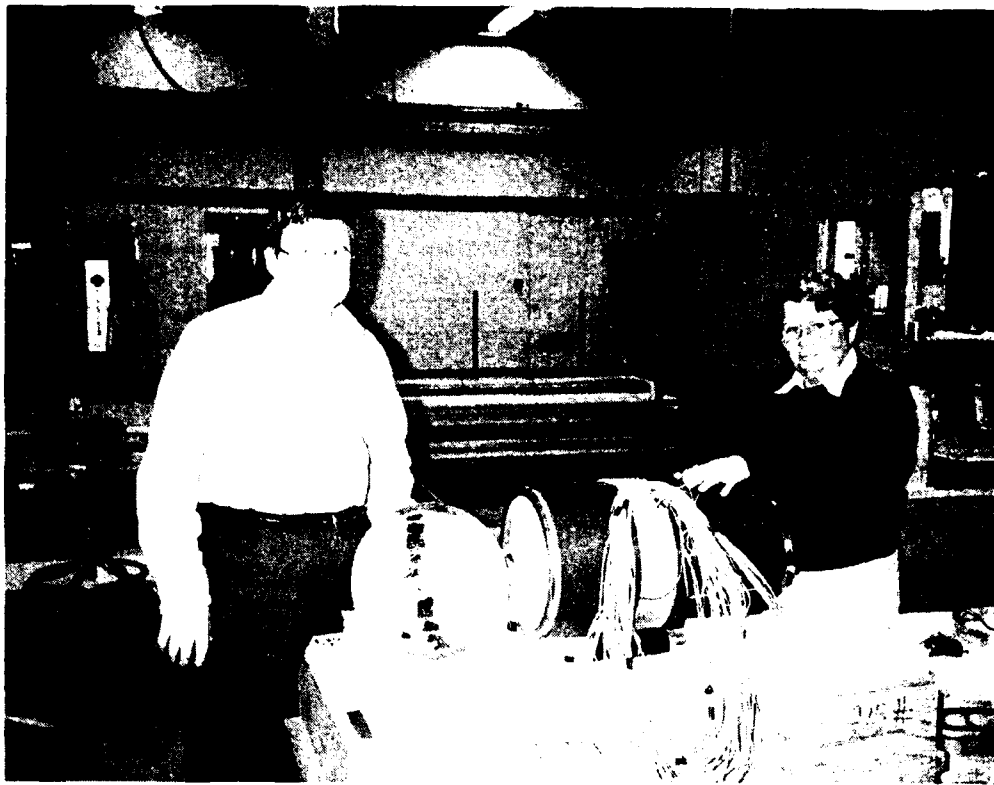
Figure. C-15. Instrumented ceramic housing test assembly 2A prior to pressure testing.

All pressure housings satisfactorily withstood a proof test to 10,000 psi, followed by many pressurizations to 9,000-psi design pressure. The compressive stresses in all hemispheres, except for the Mod 3 hemisphere, did not exceed the design stress of -150,000 psi at 9,000-psi design pressure (figure C-3). In Mod 3, while the nominal membrane stresses were below -150,000 psi, the peak hoop stress around the unreinforced polar opening approached -300,000 psi. Some spalling took place on the bearing surfaces of hemispheres

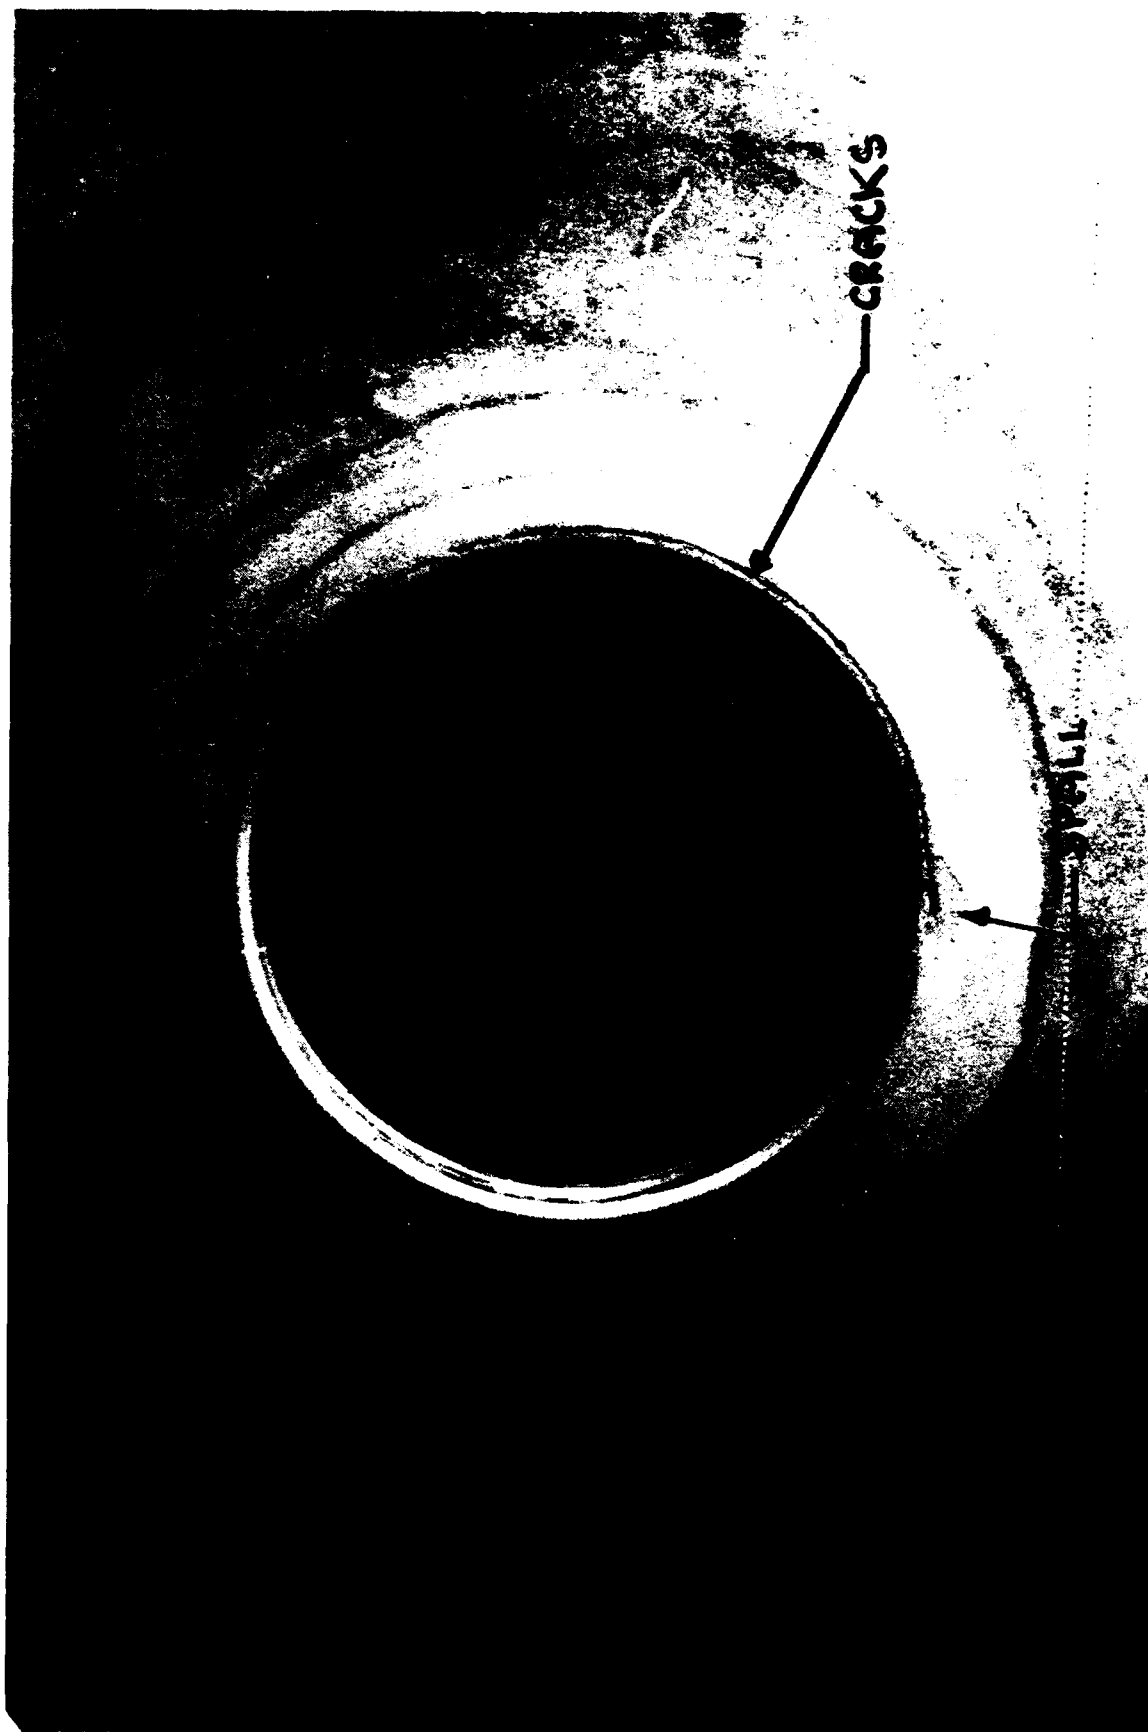
Figure C-41. Circular crack around the polar penetration in hemisphere Mod 2 generated by connector insert Revision 0 shown on figure C-29.

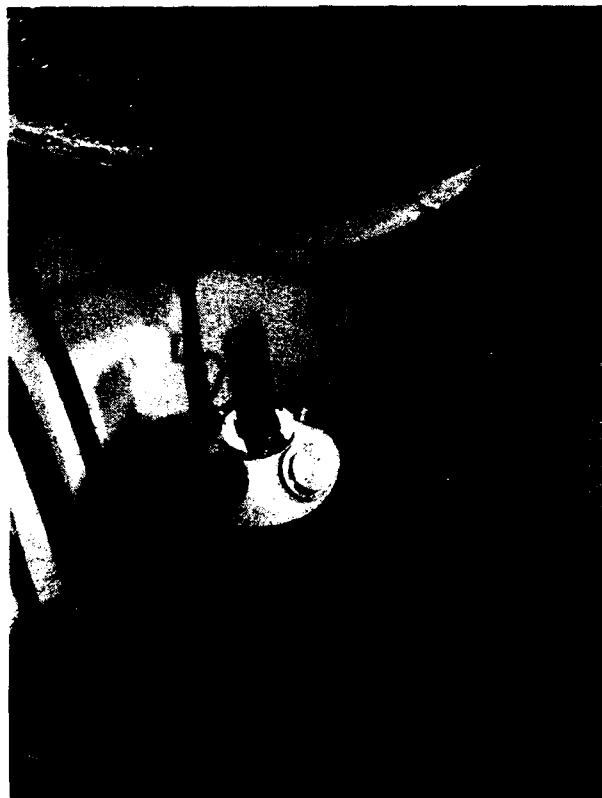
Figure C-72. Ceramic housing test assembly 2E during placement into the pressure vessel for external pressure testing.

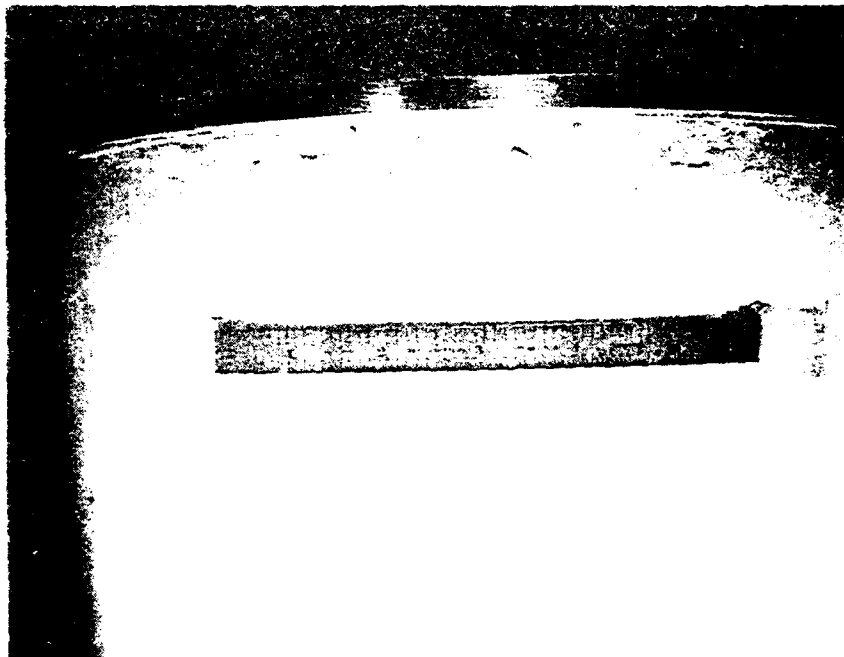
(a) Top end of cylinder, 330° to 50° location.

Figure E-1. Photomicrographs of spalling found on cylinder #2, sheet 1.

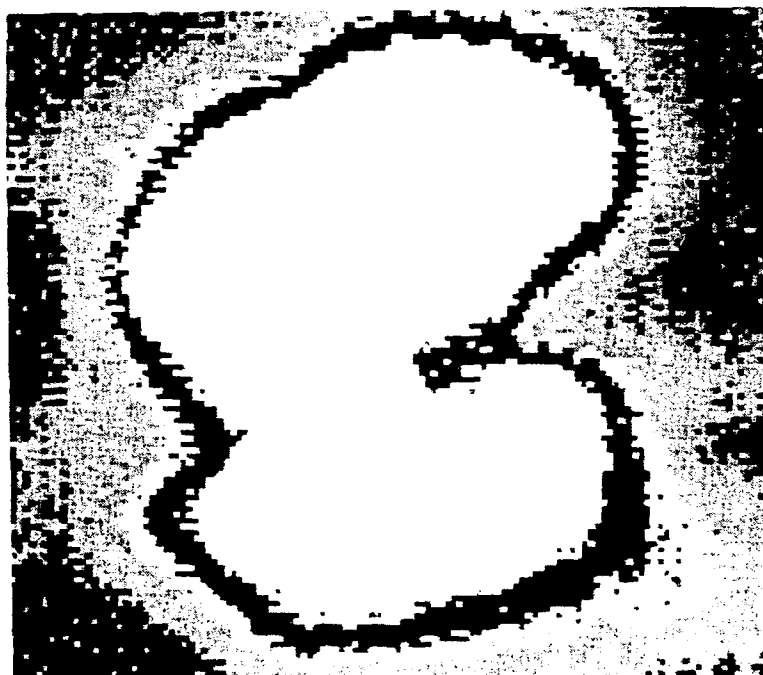
Figure E-12. Enlarged image of largest flaw indication in cylinder #3 generated by SAM with resolution of 0.0005 inch/pixel. Estimated size of indication is 0.057–0.065 inch.

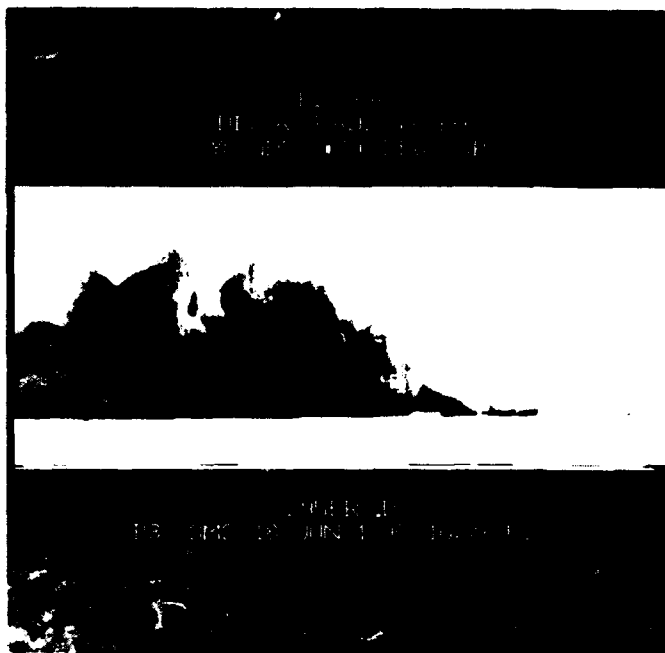
Digital Radiograph
External Spalls

Figure E-14. DR of external spalls visible above metallic end cap on cylinder #2.

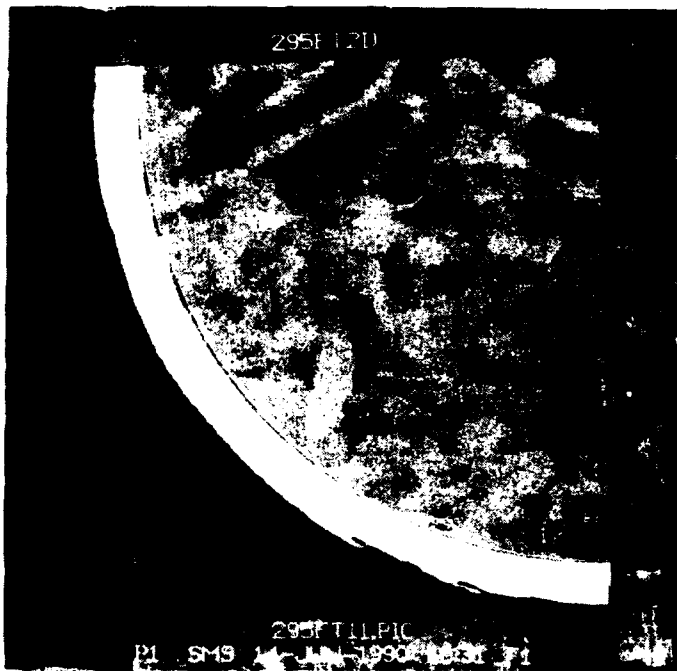
Tomograph Through
Cylinder Above End Cap

Figure E-15. RCT slice through cylinder #2 at one inch evaluation above bottom of cylinder. Note the external spall.

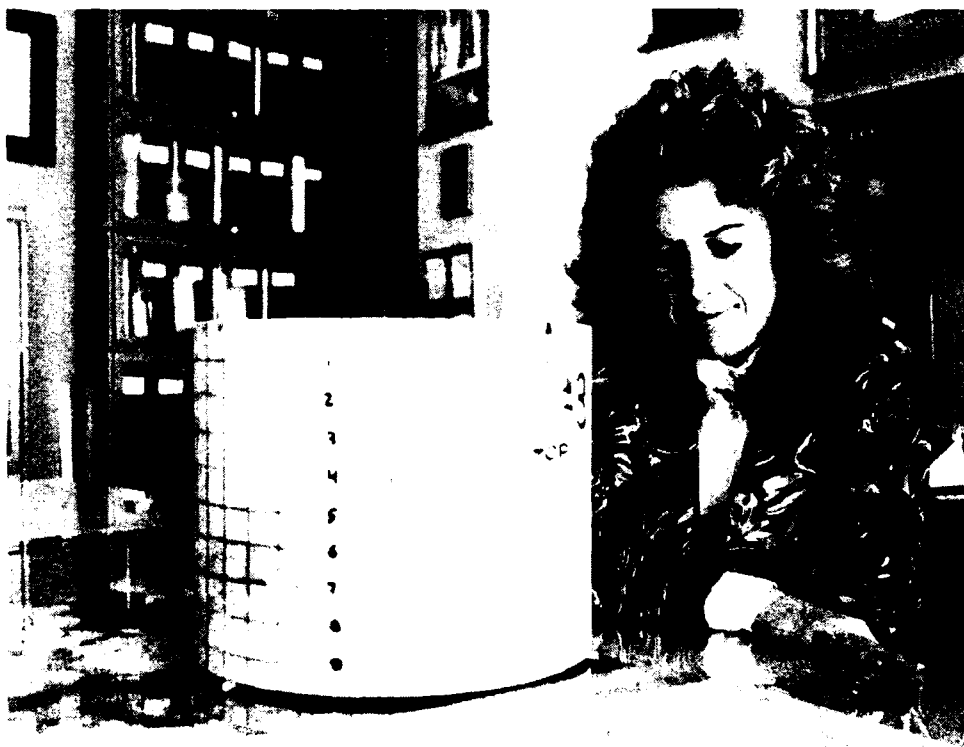
Figure E-21. Cylinder #3 after removal of spalled ends shown on figure D-20.

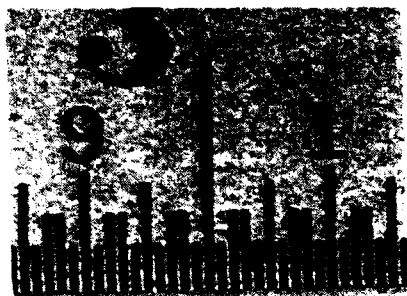
FF.
11.14", 110°, 0.200"

Figure E-27. Flaw FF cross section uncovered during incremental removal of material from exterior surface of cylinder #3.
